August 6, 2021

Adam Thompson, City Administrator
City of Ely
1570 Rowley Street
Ely, IA 52227

Re: **City Hall Building Evaluation (Phase 1)**

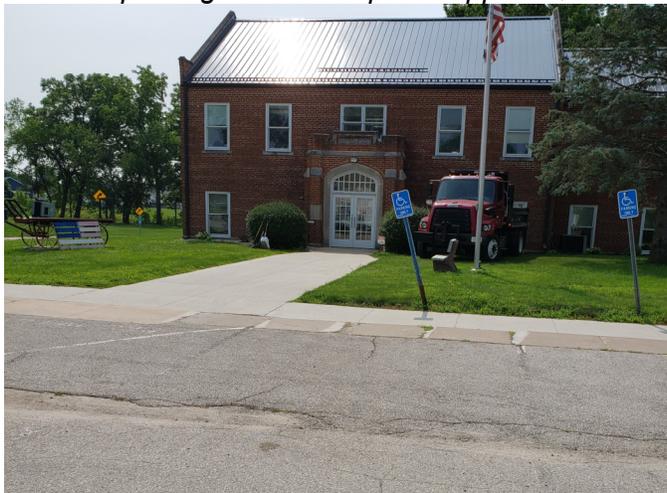
- I. ADA (Americans with Disabilities Act) Entry/Exit & Routes
 - a. Single entry point into the building is located on the northwest side facing Rowley St. It was noted that the transition strip at this entry had a height differential of more than ½". *Recommend future concrete stoop work include adjustment to address height. Cost anticipated less than \$500.*

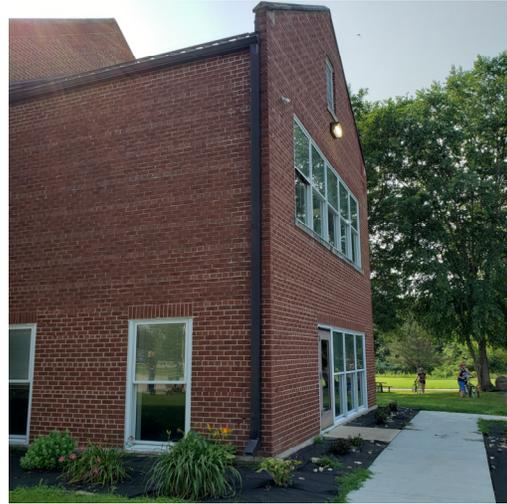
- c. Egress from the second floor is possible through the main entry/exit or through the chamber room via the exterior fire escape stair. Although both options require the navigation of stairs, these are generally acceptable in a historic structure. However, both means of egress from the second floor are located on the eastern half of the building. This poses potential problems for users on the western part of the building (offices) should there be an emergency situation between them and the exits. *One recommendation would be to consider an additional means of egress from the western office areas. Cost anticipated approx. \$15,000.* Additional recommendations will be discussed later in the report and involve reconfiguration of space.

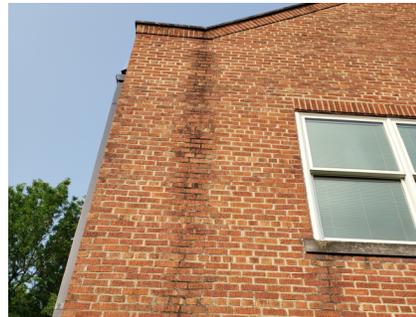
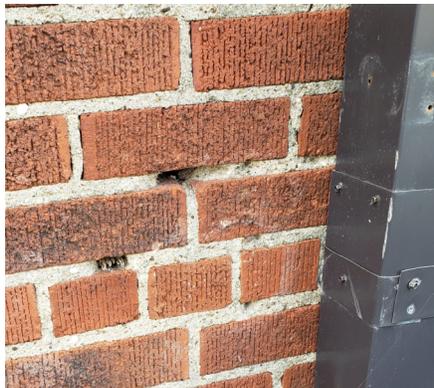
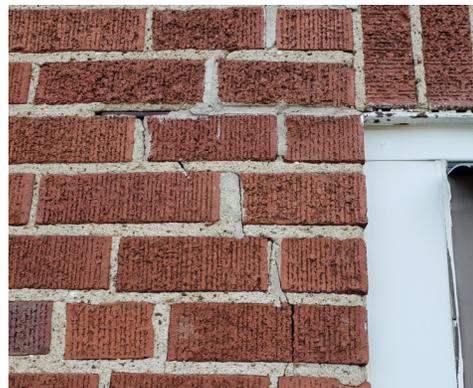
- a. Staining was observed in multiple locations on the exterior of the building. Most of this appears to be from roof or sill drainage that carried dirt and debris in its path. If the path of water travel has not been remedied and excessive wetting in these areas of staining is still present, this should be addressed first.
- b. Overall, the condition of the masonry was found to be acceptable for a building of this age. No signs of structural distress were observed. There were a few areas where mortar had begun to chip/crack and a few window heads where lintels could be observed. *Recommend engaging a contractor experienced with treatment of historical buildings to perform a cleaning of the overall building exterior followed by tuckpointing or repointing, as appropriate. As part of this work, it will be important the contractor utilize materials and techniques*

appropriate for a historical masonry structure and compatible with the existing materials. Cost anticipated \$4,000-\$5,000 for cleaning. Approx. \$60,000 for tuckpointing & repointing, depending on extent. Note that costs for work on this nature vary widely for historic buildings based on materials, treatment and availability of qualified masons. Highly recommend obtaining an evaluation and bid from a qualified mason.

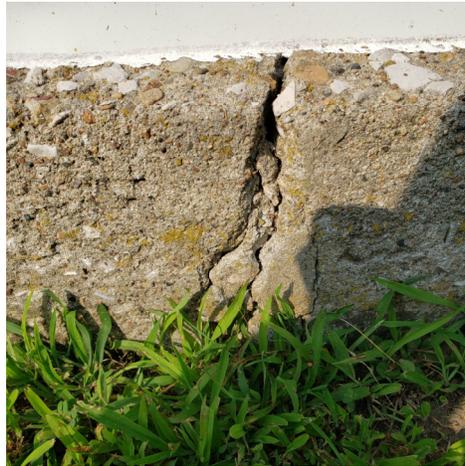
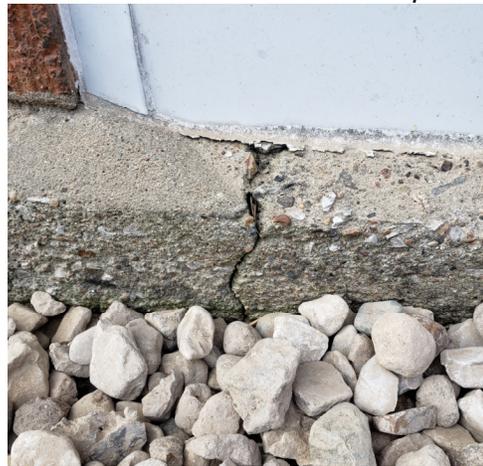
- c. A few cracks of various sizes were observed in the exterior of the foundation on multiple sides of the building. Although we observed no interior evidence of cracking or damage related to these locations, the Owner should watch for any evidence of this in the future. *Recommend watching the smaller cracks and taking action should they grow. For the larger cracks, recommend excavating surrounding soils as needed to expose the extent of the crack, removing loose concrete material, and injecting/infilling with epoxy grout crack repair or cementitious polymer modified concrete mix. A contractor experienced with treatment of historical buildings is recommended for this work. Cost anticipated*
